NEWSLETTER

Reference No. : XRD Hamburg 074
Date : May 2005 - reissue

Earth Leakage current circuit breaker trip off caused by a defective Varistor (SIOV)

High-speed / dual-speed rotor control for OPIMUS RAD / RF / C

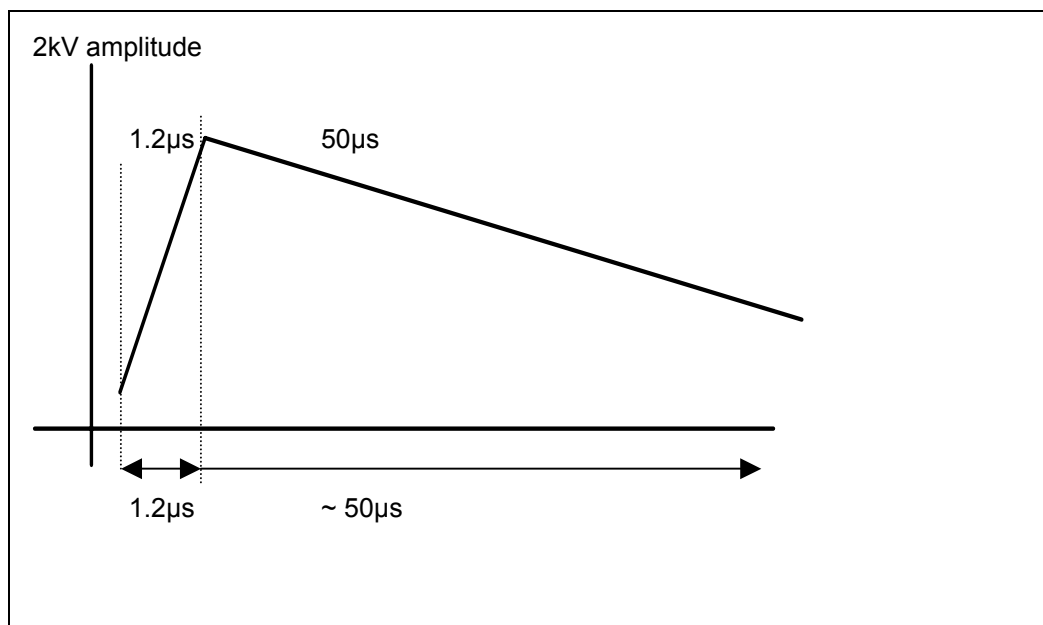
- Energy storage 33Joule for 2ms
- Continuous load 1W
- Surges may occur during switching operation or lightning. A surge is defined as follows:
